BHI-01282

Hanford B Reactor Building Hazard Assessment Report

Submitted by: Bechtel Hanford, Inc.

June 1999

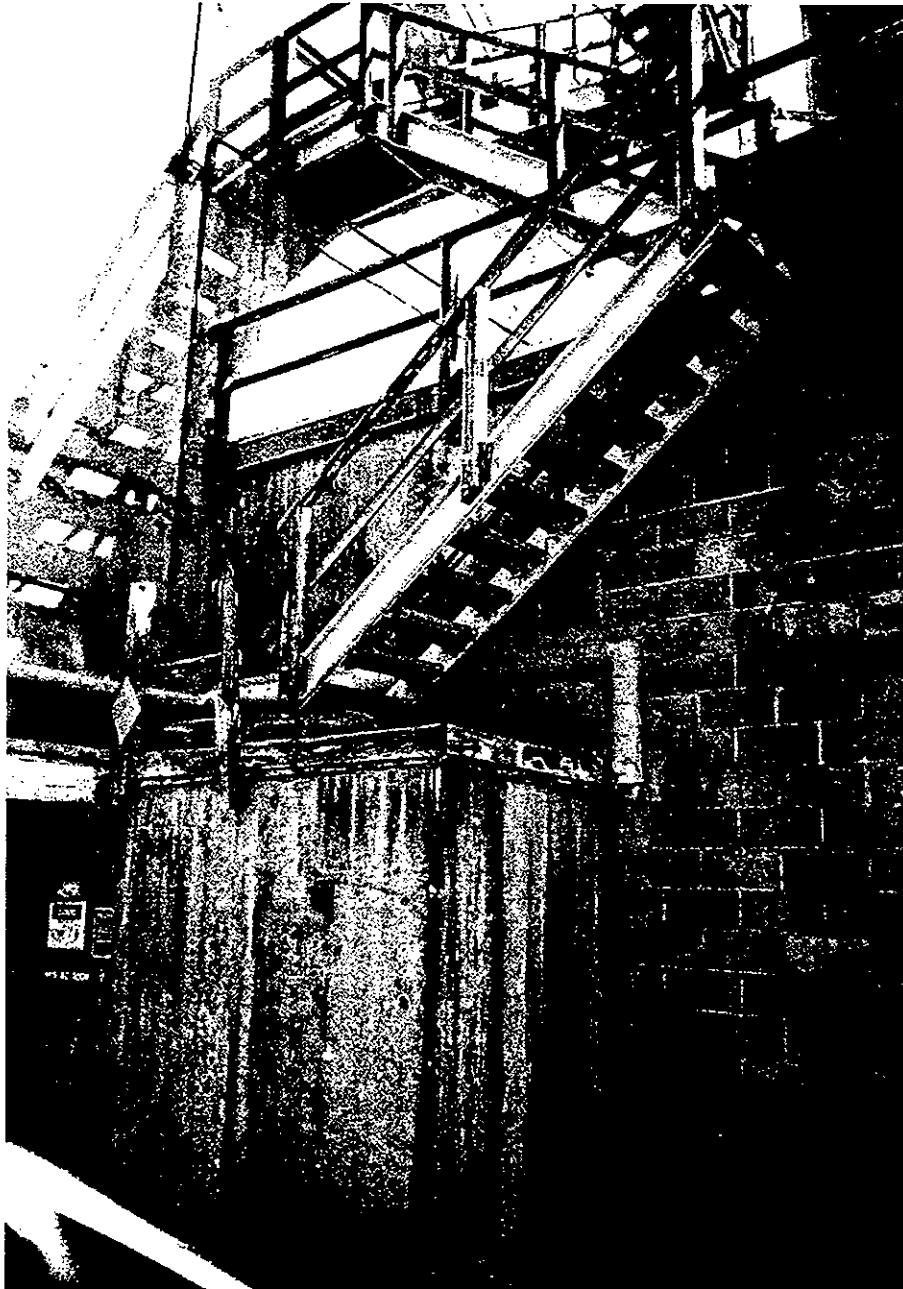
- Exterior stairway up south side of reactor: The wooden stairway (with concrete treads) up the south side of the reactor building has not been maintained and appears to be in poor condition. The wood has weathered, nails/bolts appear to be loose, and treads appear to have major cracks. (*Photograph 1*)
- Broken conduit with exposed electrical conductors. (*Photograph 2*)
- Covers (doors) missing from transformers.
- Peeling paint on both metal and wood surfaces may contain lead.
- Building penetrations need to be sealed to prevent animal intrusion.
- The wood roof over the tool/storage area on the north side shows signs of water damage.
- Wood covers over the stack plenum openings are weathered. (*Photograph 3*)

Photograph 1. Wood Stairway on South Side of the Reactor Building.

The wooden stairway (with concrete treads) up the south side of the reactor building has not been maintained and appears to be in poor condition. The wood has weathered, nails/bolts appear to be loose, and treads appear to have serious cracks.

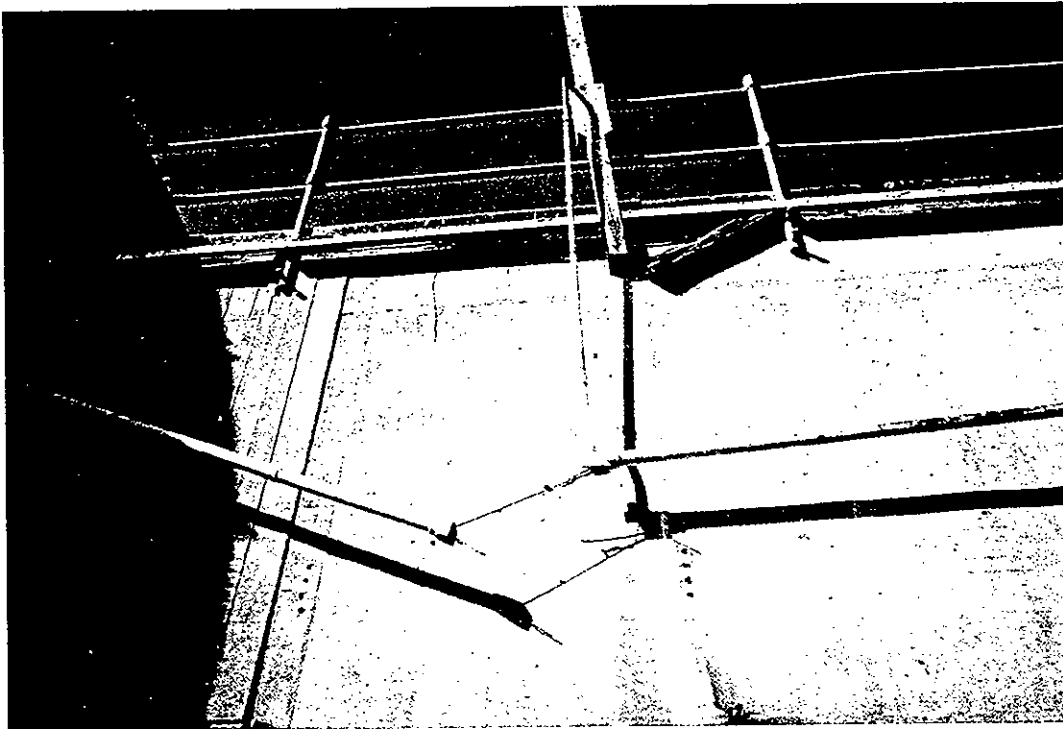
Photograph 2. Broken Conduit with Exposed Electrical Conductors.

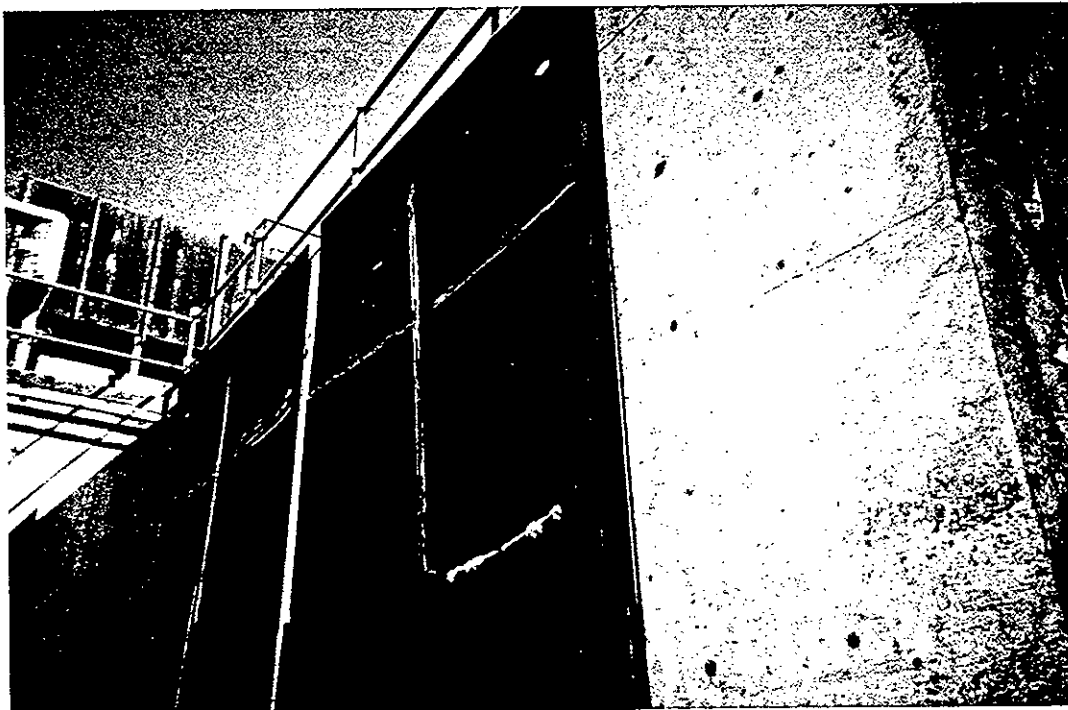
Photograph 3. Wood Covers Over the Stack Plenum Openings.

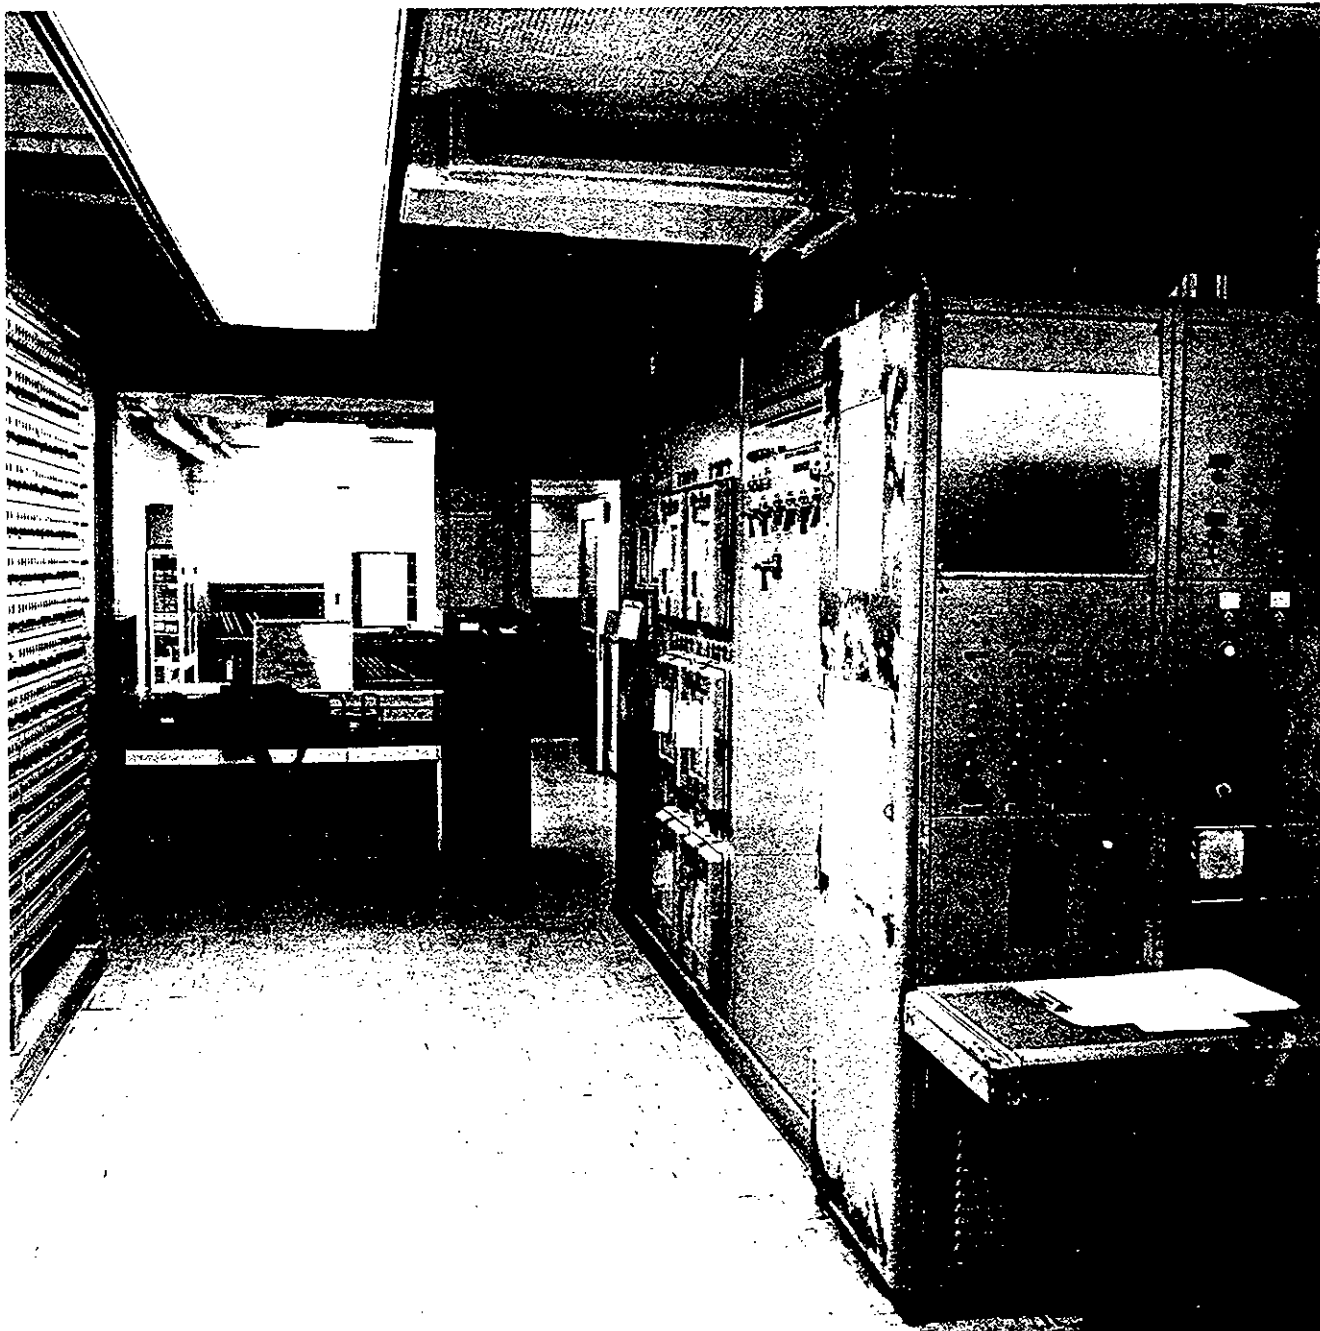
Photograph 4. Peeling Paint in Control Room.

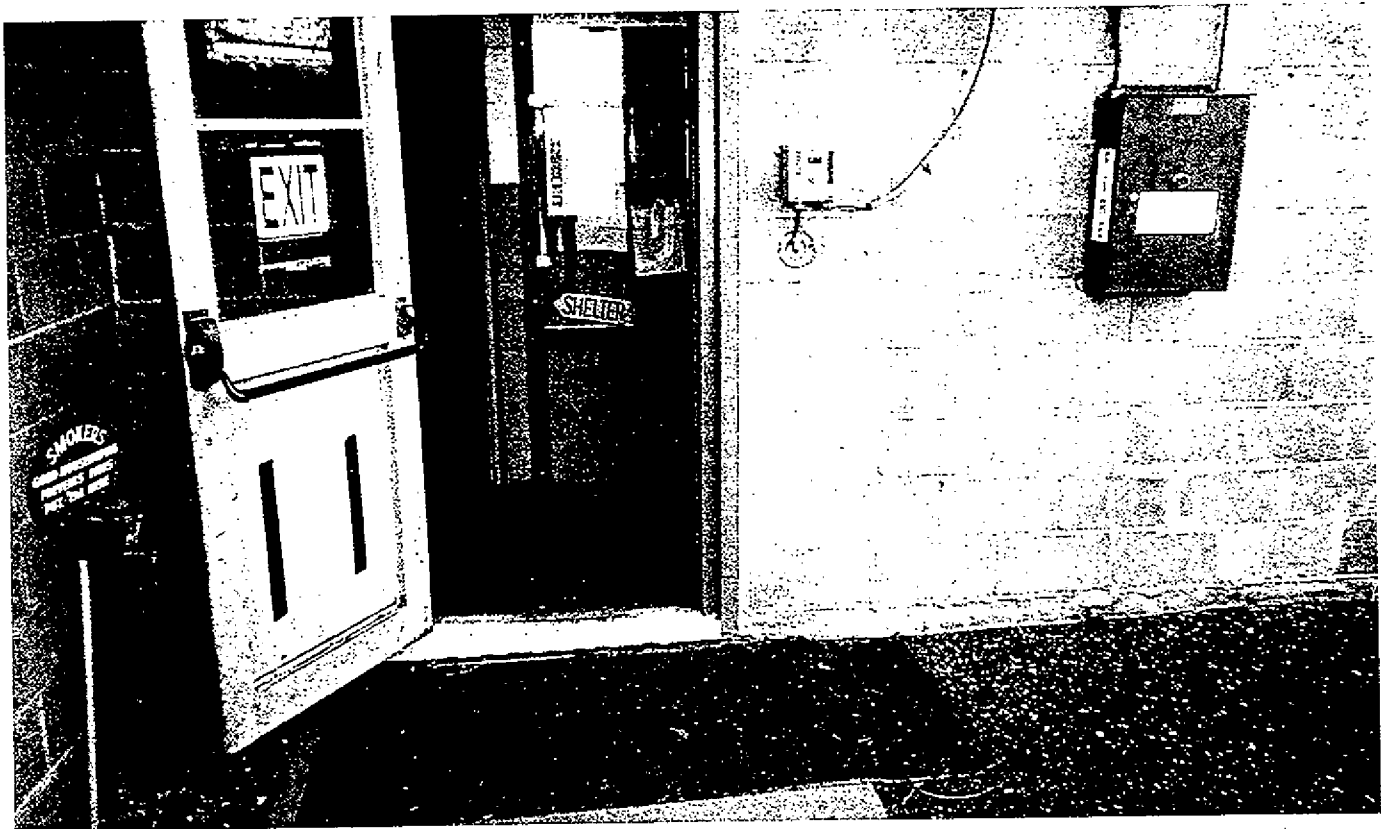
Photograph 5. Tripping Hazard Through Doorway.

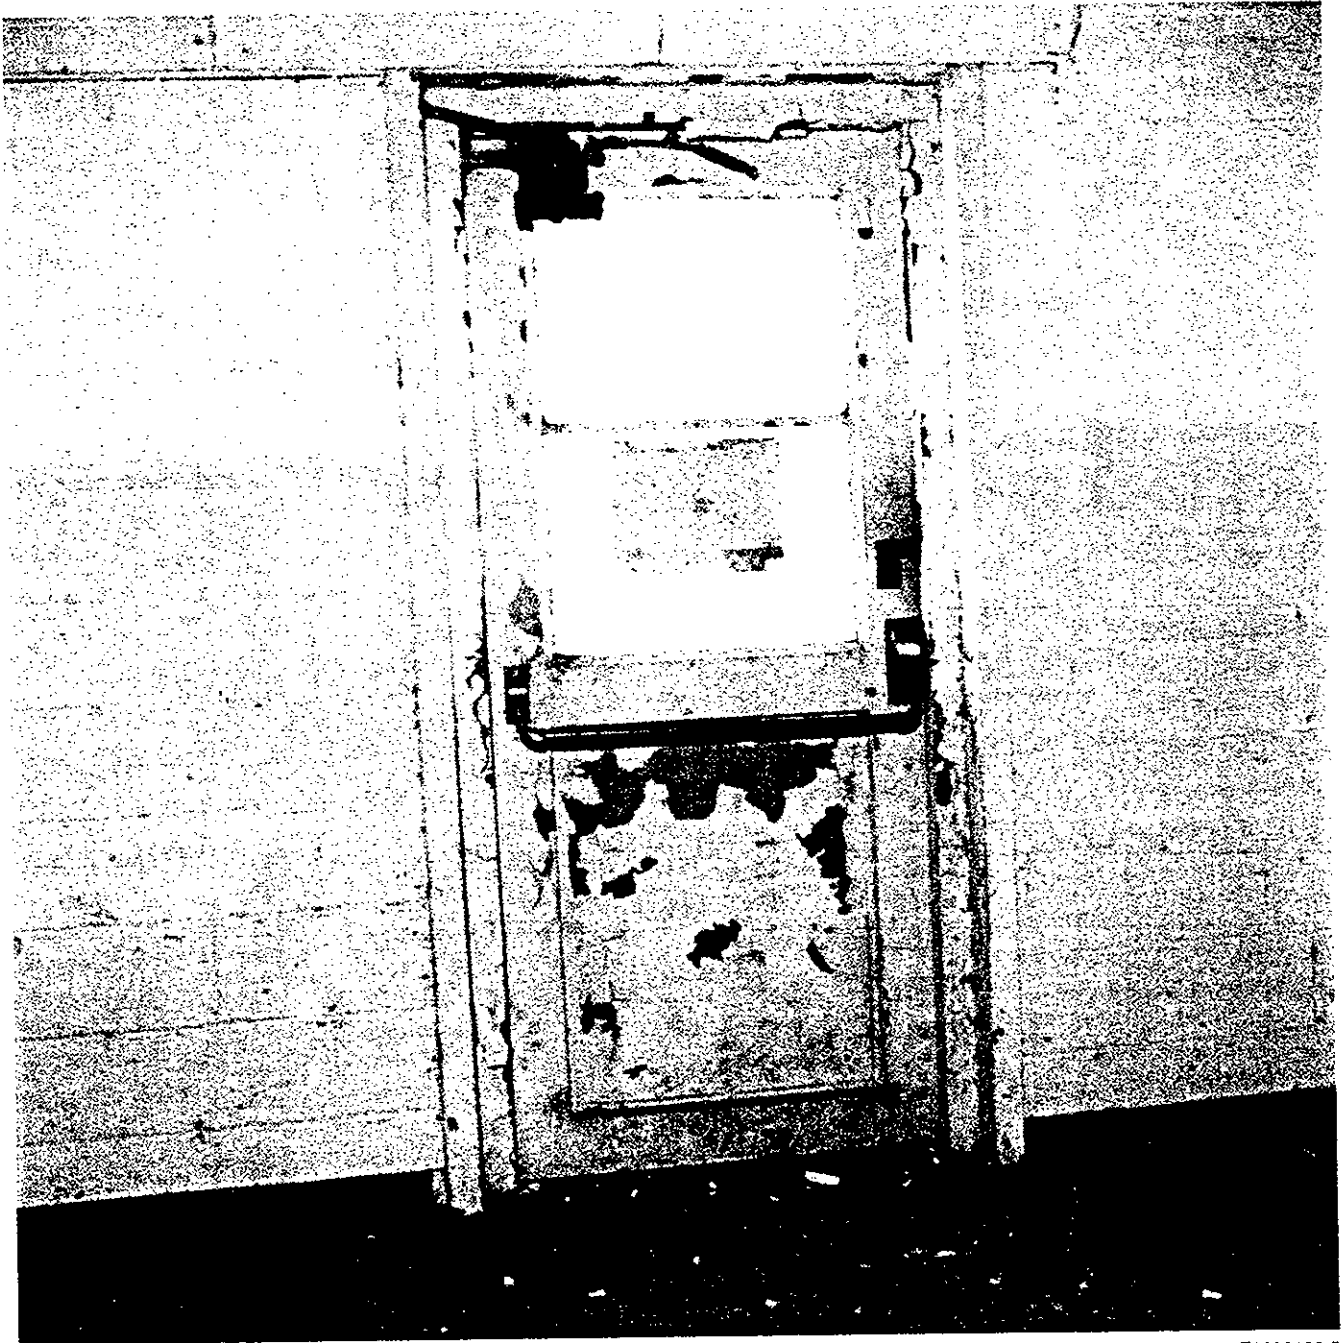
Photograph 6. Peeling Paint in the Lunch Room.

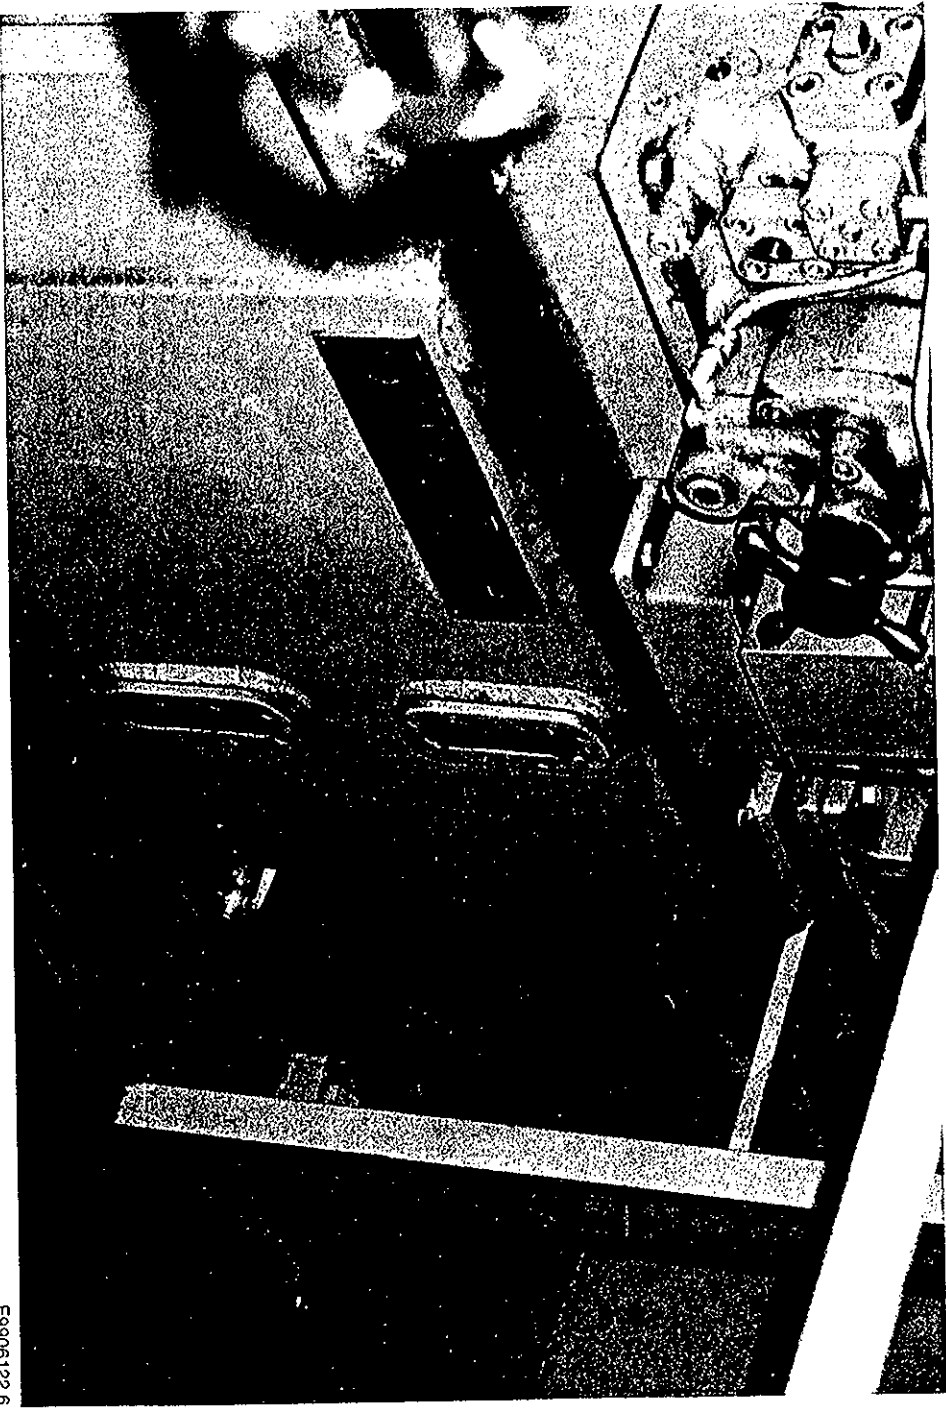
Photograph 7. Leaking Oil on Equipment.

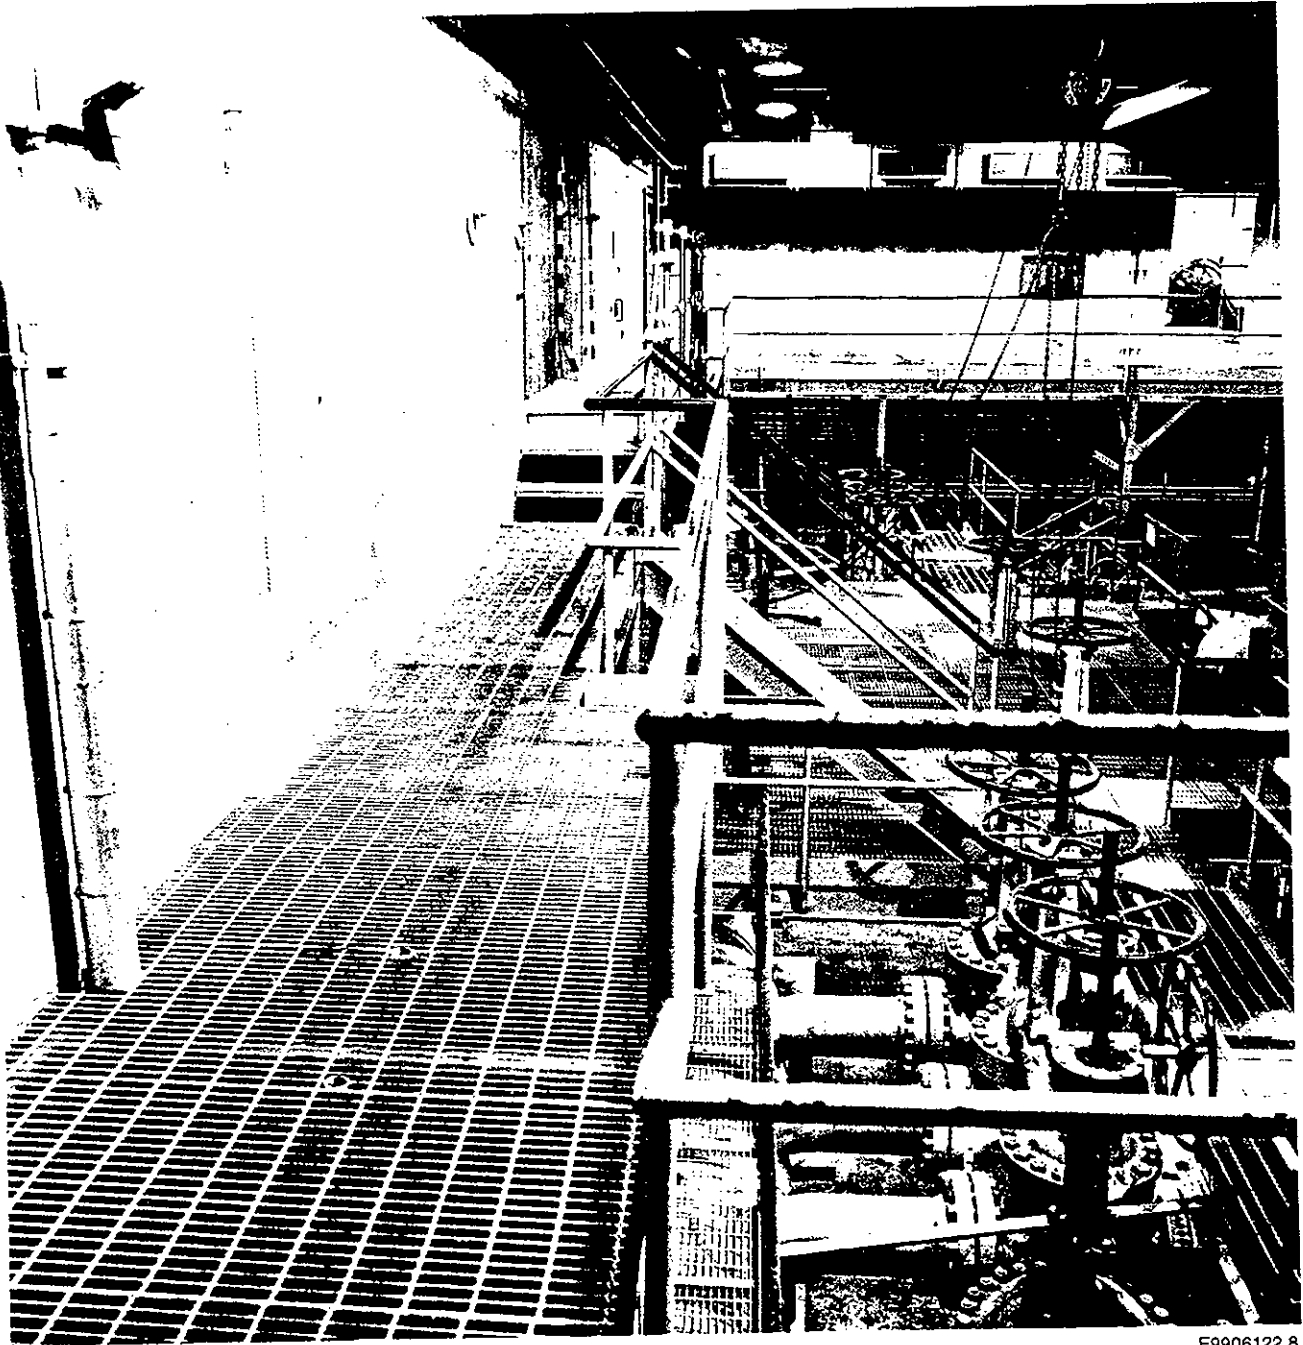
- Lunch room: Old fluorescent fixtures, possible PCBs.
- Room No. 5 (electrical equipment): Semi-volatile organics.
- Room No. 5: Batteries for the emergency lights.
- Fan rooms: Emergency lights and batteries.
- No. 8 fan supply room: Calcium chloride or similar desiccant in moisture absorbers on air lines.
- Fan room: Oil on casings of fan motors. (*Photograph 7*)
- Fan room: Dehydrator has oil in it and is dripping on the floor.
- Room No. 5 (electrical equipment): Oil in the seismometer.
- No. 8 fan supply room: Oil in air line accumulators.
- No. 9 fan cell: Oil in moisture separator.
- Basin viewing room: Oil separators on air line.
- Fan Rooms: Oil in motors and fans, hydraulic pistons on dampers, and hydraulic fluid in Kwik Srak fork truck.
- Supply fan room: No lighting.
- Grated walkways could create a tripping hazard to individuals with heeled footwear. (*Photograph 8*)

Photograph 8. Grated Walkways.

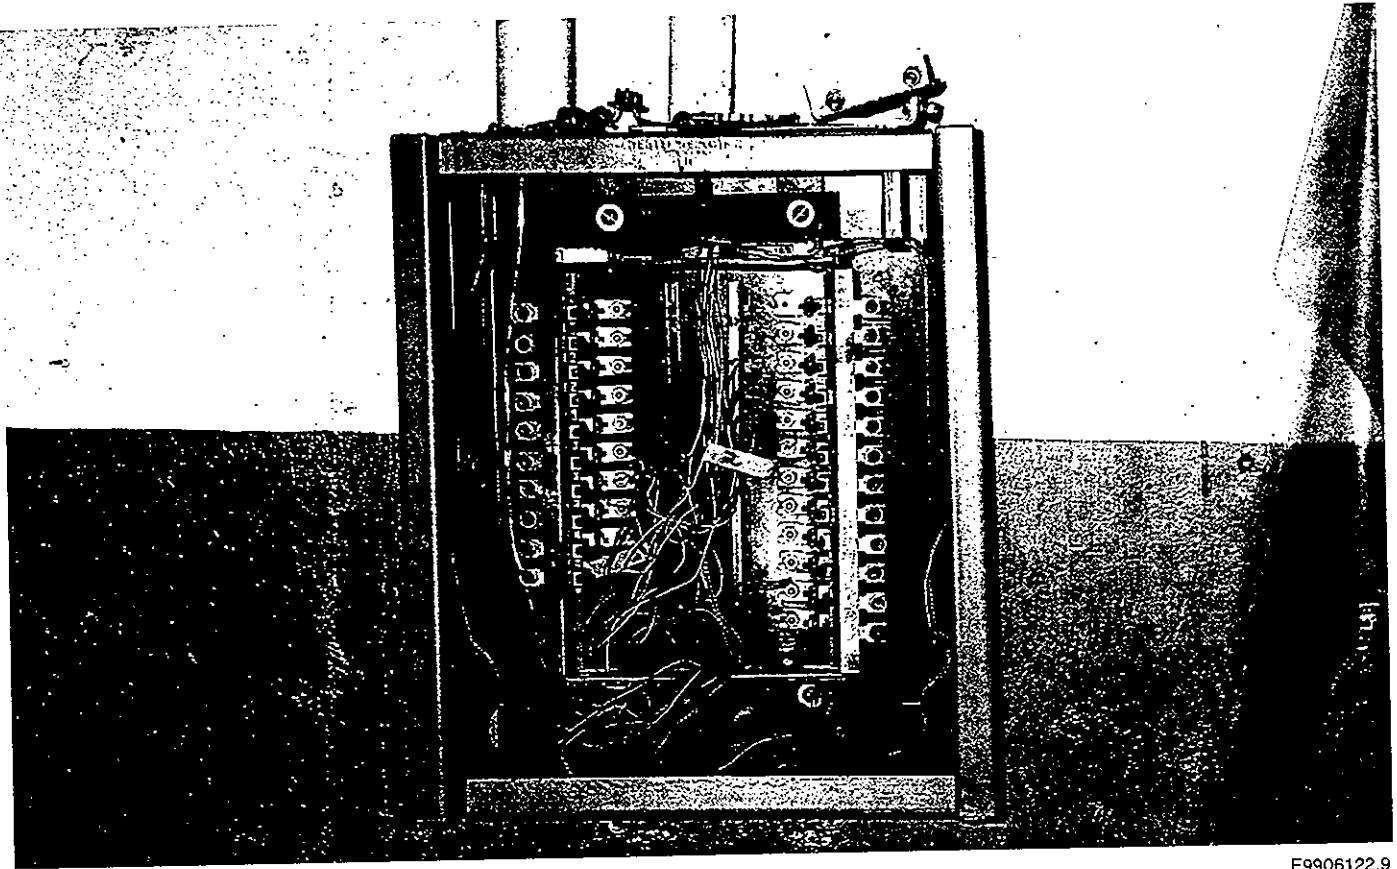
Photograph 9. Missing Electrical Covers.

- Electric equipment room: Missing covers on the wireway and gutters. Locate energized lines and isolate, label, or put barriers in place. Exposed wiring on the "C" platform should have "DO NOT TOUCH" signs on barriers. (*Photograph 9*)
- Electrical equipment room No. 35: Incandescent light fixtures missing lamps and globes. Fluorescent lighting fixtures need repair.
- Electrical switch gear room (Room 25): Wiring hanging from the wireway and sliding access doors are not secured from opening and may contain energized circuits.
